MONUMENT RECORD

Corner ID: **CICr_F08**

South-West 1/16 Corner

Section 08- T07N-R01W, 2nd P.M.

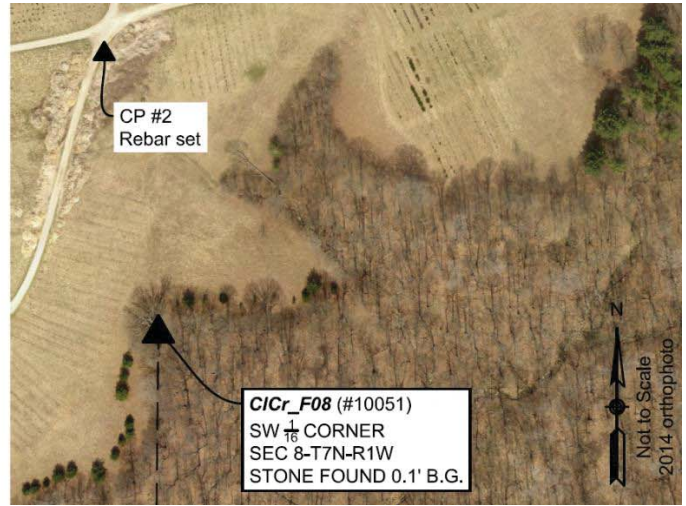
MONUMENT: Describe monument set or found (Include material type, scribing, distance above/below grade, dimensions.)
0.4' x 0.6' limestone with cut "+" found 0.1' below grade

Photo Orientation & Description: CICr_F08

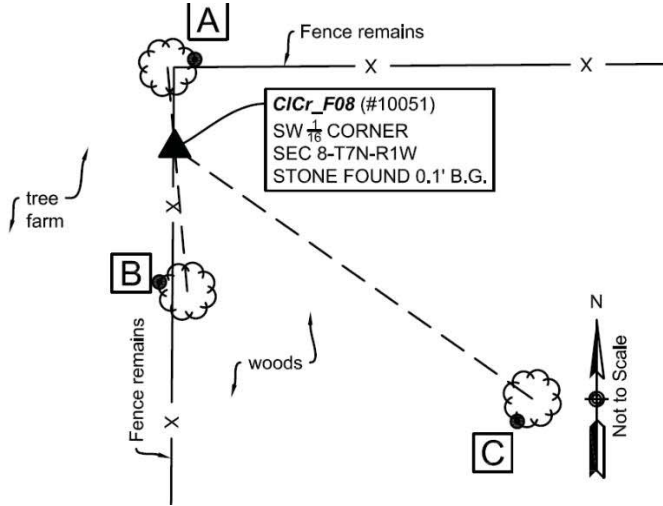
Photo Orientation & Description: Looking north at CICr_F08
